Manhole Inspection Summary

Manhole # S43W1_015MH

Location Address: **3400 9th St.**

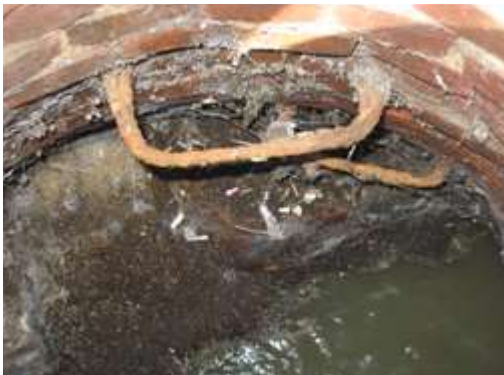
Steps Count: **2** Missing: **0** ☒ **Corroded**

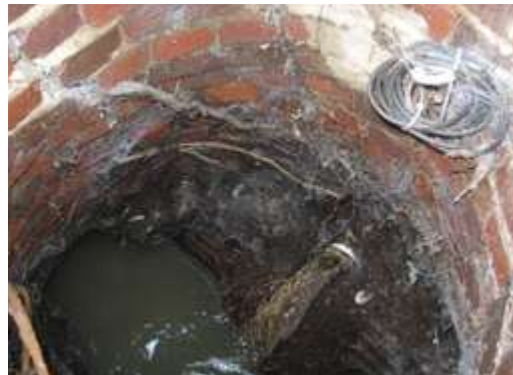
Defect 1

Condition: ☐ Sound ☐ Cracked ☒ **Root Intrusion** ☐ Loose Brick ☐ Deteriorated

Condition: ☐ Sound ☐ Cracked ☒ **Root Intrusion** ☐ Deteriorated ☐ Leaks ☒ **Debris**

Root intrusion and debris

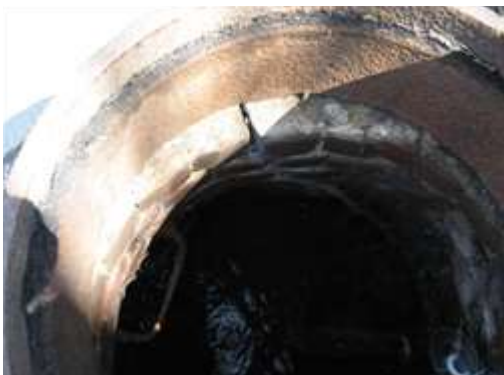
Defect 2

Frame Offset: **3** (in.) Condition: ☒ Sound ☐ Cracked ☐ Leaks

Condition: ☐ Sound ☒ **Cracked** ☒ **Root Intrusion** ☐ Loose Brick ☐ Deteriorated

Infiltration: ☐ None ☐ Joint ☒ **Cracks** ☐ Mortar ☒ **Roots** ☐ Wall

Frame Offset and Cracked Chimney

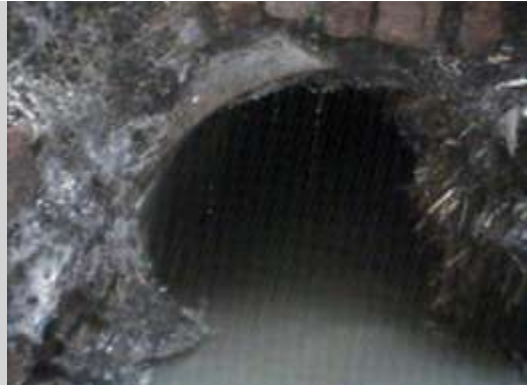
12 O'Clock Outflow

24 in. Circular Gravity Sewer
Pipe Out @ 12 O'Clock

Pipe Height: **24** (in.) Rod and Bar (Angled)
Pipe Material: **Clay** ☐ Pipe Lined
Invert Depth: **7.38** (ft.) Flow Characteristics: **Fast**
Deposits: ☒ None ☐ Mud ☐ Sludge ☐ Debris ☐ Grease
Silt Depth: (in.) Deposits Extent:
Infiltration: **None** Pipe Seal Cond: **Roots**

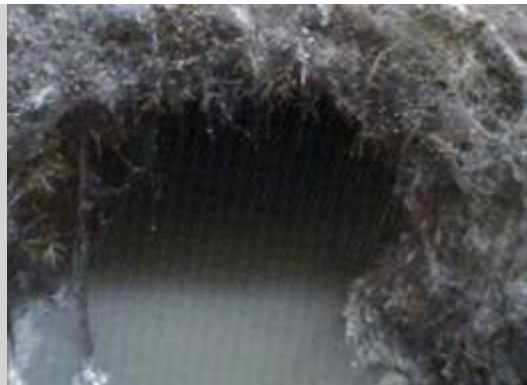
6 O'Clock Inflow

24 in. Circular Gravity Sewer
Pipe In @ 6 O'Clock

Pipe Height: **24** (in.) Rod and Bar (Angled)
Pipe Material: **Clay** ☐ Pipe Lined
Invert Depth: **7.20** (ft.) Flow Characteristics: **Fast**
Deposits: ☒ None ☐ Mud ☐ Sludge ☐ Debris ☐ Grease
Silt Depth: (in.) Deposits Extent:
Infiltration: **None** Pipe Seal Cond: **Unknown**
